Home Inspection Report

Dough, Jane
1313 Mockingbird Ln.
Yourtown, Arkansas 72000

Optimal Home Inspection

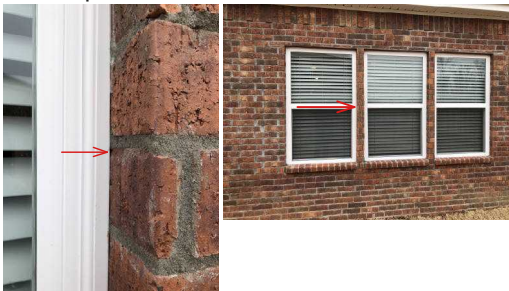
2. Acceptable Trim: Vinyl, Wood
3. Acceptable Fascia: Wood, Aluminum - Covered by siding, unable to inspect the underlying wood.
4. Acceptable Soffits: Vinyl
5. Acceptable Flashing: Aluminum
6. Acceptable Entry Doors: Wood, Fiberglass
7. Acceptable Patio Door: Wood, Fiberglass
8. Acceptable Windows: Vinyl - Gap in sealant at right hand side of window closest to the patio door. This could lead to moisture intrusion. Recommend certified professional be contacted for further evaluation and repair.

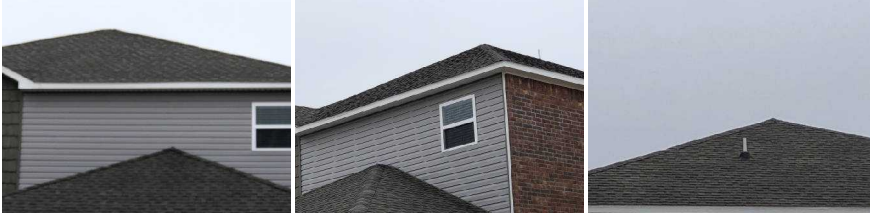
1. Method of Inspection: Ground level with HD binoculars

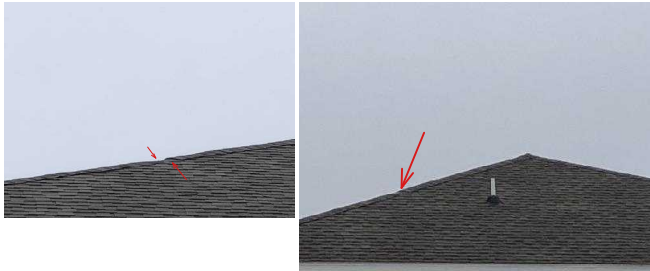
Marginal Issue - Hip on upper roof at right front corner of house missing shingles. This could lead to moisture intrusion. Recommend a certified professional be contacted for further evaluation and repair.

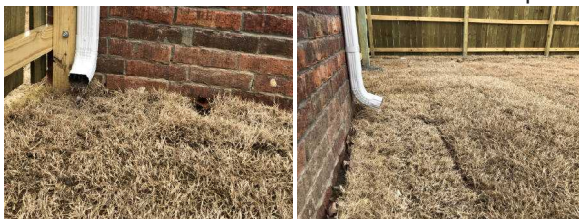
8. Acceptable Gutters: Aluminum
9. Acceptable Downspouts: Aluminum
10. Acceptable Leader/Extension: None installed - No extensions/splash blocks installed at sides and rear of home. This can lead to excess water build up at the foundation and erosion of the swale. Recommend installation of extensions/ splash blocks to move water away from foundation/swale.

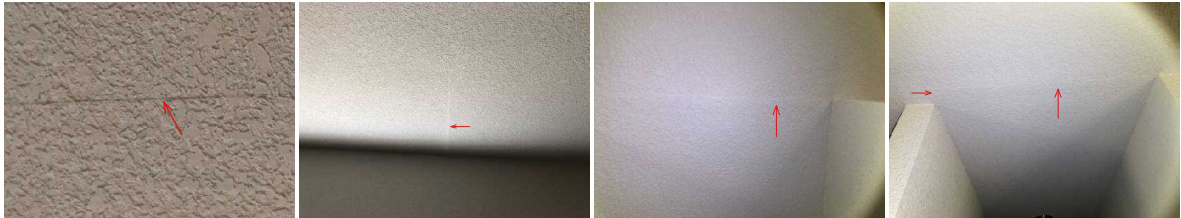
There are signs at the first floor over the right hand window of the living room, near stairway, and at the hallway entrance to garage that show signs of cracking/ recent repair. These are all at gypsum joints and should be monitored as they could be attributed to settlement and future separation may occur.

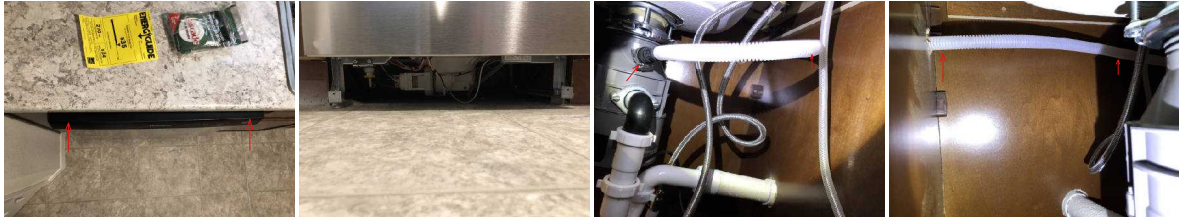
Dishwasher: (continued)

4. Marginal Dishwasher: Frigidaire - Dishwasher installed slightly cockeyed, with left side protruding out further from counter in right side. This is an aesthetic problem that does not affect the overall function of the unit. Recommend a certified professional be contacted for further evaluation and repair.
Dishwasher missing kickplate at base of unit. This is an aesthetic issue that does not affect the overall function of the unit. Recommend a certified professional be contacted for further evaluation and repair.
Drain line improperly routed. Drain hose needs to run closer to bottom of countertop to avoid possible siphon of waste water. This can lead to debris build up and mold in the dishwasher. Recommend a certified professional be contacted for the evaluation and a pair.

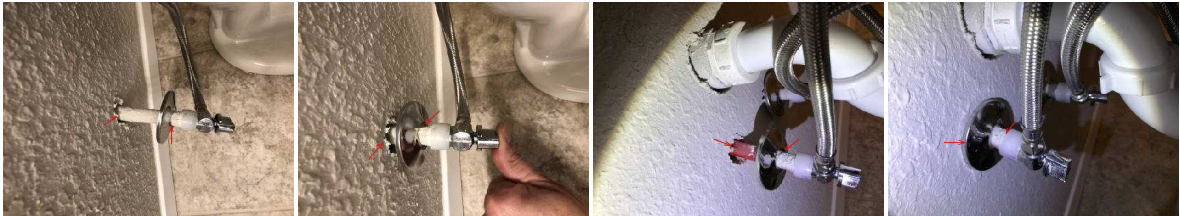
- 3. Marginal Water Lines: PEX - Multiple supply water lines are not properly secured at wall. Recommend a certified plumber be contacted for further evaluation and repair.

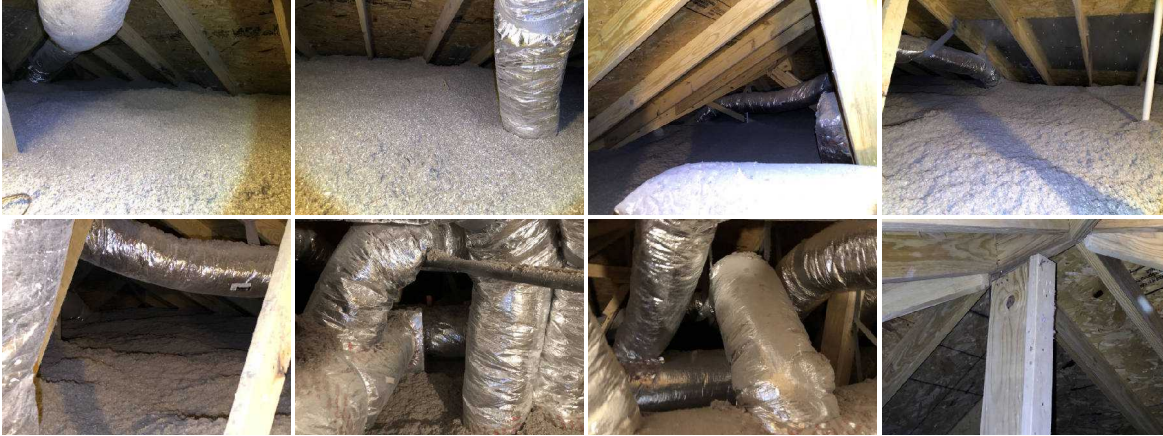
1. Method of Inspection: From the attic access

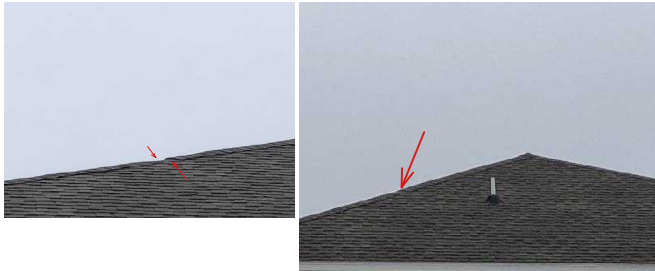
1. Main Roof Surface Material: Asphalt shingle - Note *Exposed fasteners on the exhaust vents, plumbing vents, roof vents, and ridge cap. While not an immediate concern, exposed fasteners can lead to water penetration. Recommend a UV rated exterior grade sealant be applied to all exposed fasteners (this will need to be repeated every 3-5 years).

Marginal Issue - Hip on upper roof at right front corner of house missing shingles. This could lead to moisture intrusion. Recommend a certified professional be contacted for further evaluation and repair.

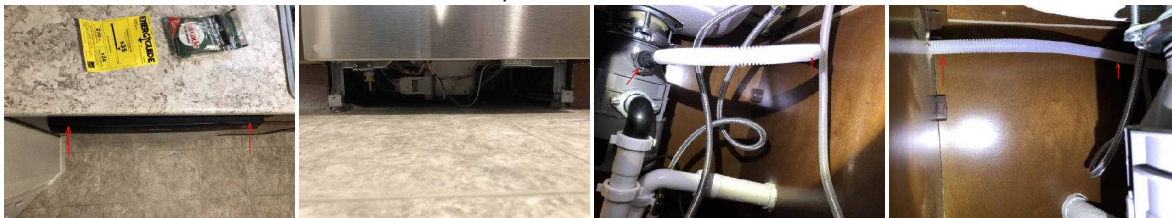
2. Dishwasher: Frigidaire - Dishwasher installed slightly cockeyed, with left side protruding out further from counter in right side. This is an aesthetic problem that does not affect the overall function of the unit. Recommend a certified professional be contacted for further evaluation and repair.
Dishwasher missing kickplate at base of unit. This is an aesthetic issue that does not affect the overall function of the unit. Recommend a certified professional be contacted for further evaluation and repair.
Drain line improperly routed. Drain hose needs to run closer to bottom of countertop to avoid possible siphon of waste water. This can lead to debris build up and mold in the dishwasher. Recommend a certified professional be contacted for the evaluation and a pair.

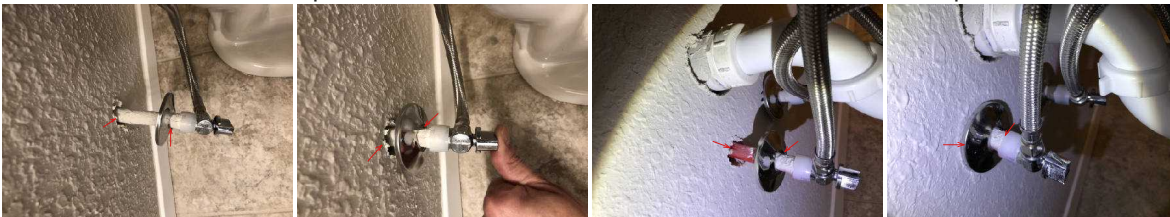
5. Water Lines: PEX - Multiple supply water lines are not properly secured at wall. Recommend a certified plumber be contacted for further evaluation and repair.
